Case Studies: Effect of Fasteners Bridging Resilient Channels on AIIC Performance in Wood-Framed Condominiums

Pier-Gui Lalonde ^{*1}

¹ Integral DX Engineering Ltd., Ottawa, Ontario, Canada.

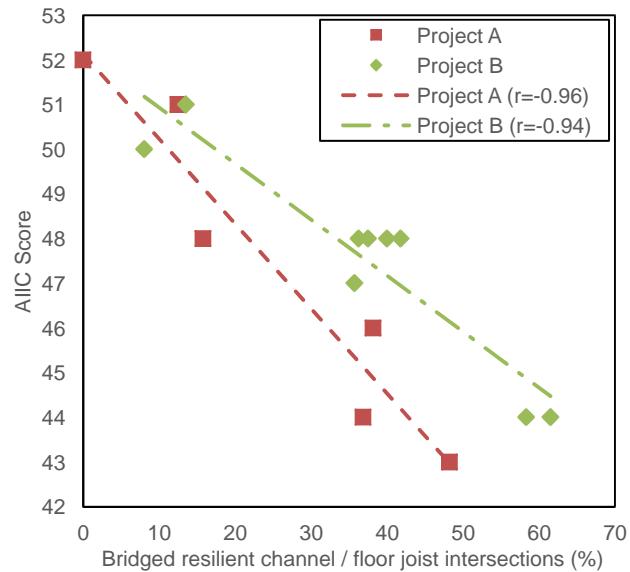
For both projects discussed in this paper, a strong correlation was found between the percentage of resilient channel / floor joist intersections with bridging fasteners, and the AIIC score.

Figure 1 below shows the relationship between the rate of bridged resilient channel / floor joist intersections and the AIIC score for both Project A and Project B. Figure 1 also includes best-fit lines and correlation coefficients (r) for each project. The data show that AIIC performance drops significantly as the occurrence of bridging fasteners increases. In Project A, a rate of 16% reduced AIIC performance by four points, and a rate of 48% reduced AIIC performance by nine points, relative to one test scoring AIIC 52 in which no errant fasteners were found. In Project B, AIIC performance was reduced by two points for a rate of 8%, and eight points for rates of 58% and 62%, relative to the minimum performance expectation of AIIC 52.

Figure 1: Relationship between AIIC scores and the percentage of bridged resilient channel / floor joist intersections
