CASE STUDY: RETROFITTED SOLUTION TO ADDRESS SOUND FLANKING VIA WINDOW MULLIONS OF STACKED RESIDENCES

Pier-Gui Lalonde^{*1}

¹Integral DX Engineering Limited, Ottawa, Ontario, Canada

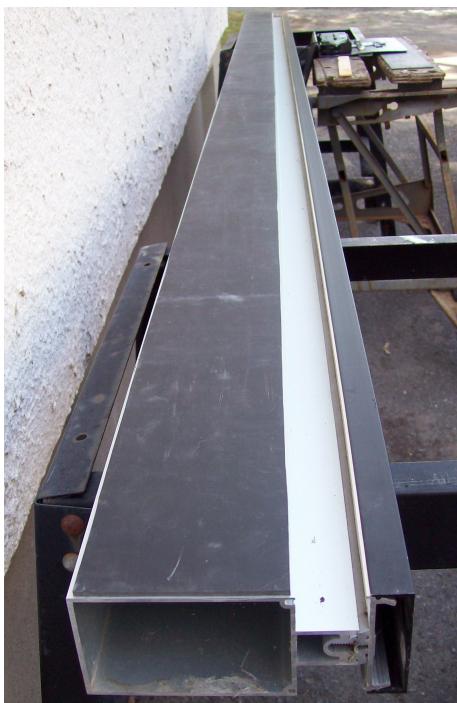
Finally, the insulation was removed, and tests were completed with one and two of the mullion surfaces covered with a barium-loaded vinyl product, which had been selected for a high surface weight (2.0 lb/ft², or approximately 9.8 kg/m²). The stimulus and measurements were both located on surfaces without the mass-loaded barrier treatment. The acceleration response was reduced by approximately a factor of 2 with two of the three suite-facing surfaces treated, compared to the un-treated condition.

Figure 1: Validation testing setup, with mass-loaded barrier applied to one of the window mullion surfaces.

The testing results showed measurable but modest reductions of vibration transmission by adding mass-loaded barriers under the test conditions. Various adhesives were also tested for their suitability to hold the mass-loaded barrier in place and ease of removal.

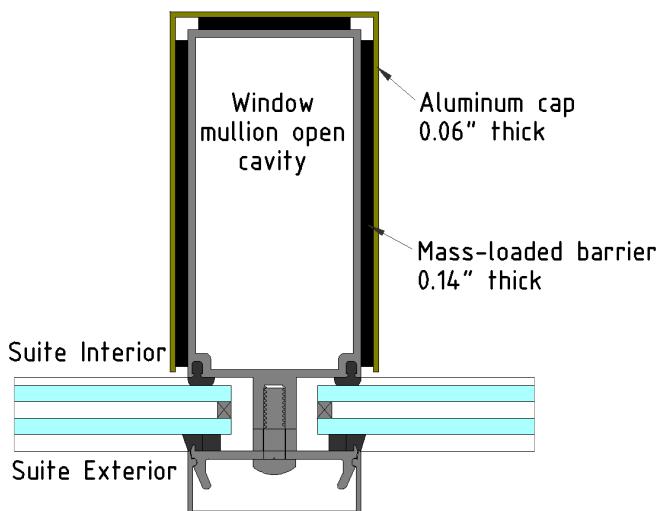
Figure 2: Cross-section of window mullion with acoustic treatment.

The final noise mitigation plan was to affix a mass-loaded barrier to each of the three suite-facing surfaces of each vertical window mullion within the third floor suite. The mass-loaded barriers would then be covered with

custom-fabricated aluminium caps, colour-matched to the window frames. To ensure a more consistent look, some horizontal window mullions also received the same treatment. Compared to the validation testing, the mass-loaded barriers would cover a shorter span, but each of the three suite-facing surfaces would receive the treatment (compared to only two of three for the testing). The aluminium caps would provide additional mass, which could only further reduce airborne and structure-borne sound transfer.
